Debris/Ice/TPS Assessment and Integrated Photographic Analysis of Shuttle Mission STS-79

**DEBRIS/ICE/TPS ASSESSMENT
AND
INTEGRATED PHOTOGRAPHIC ANALYSIS
OF
SHUTTLE MISSION STS-79**

16 September 1996

Shuttle Ice/Debris Systems
NASA/KSC/PK-H7

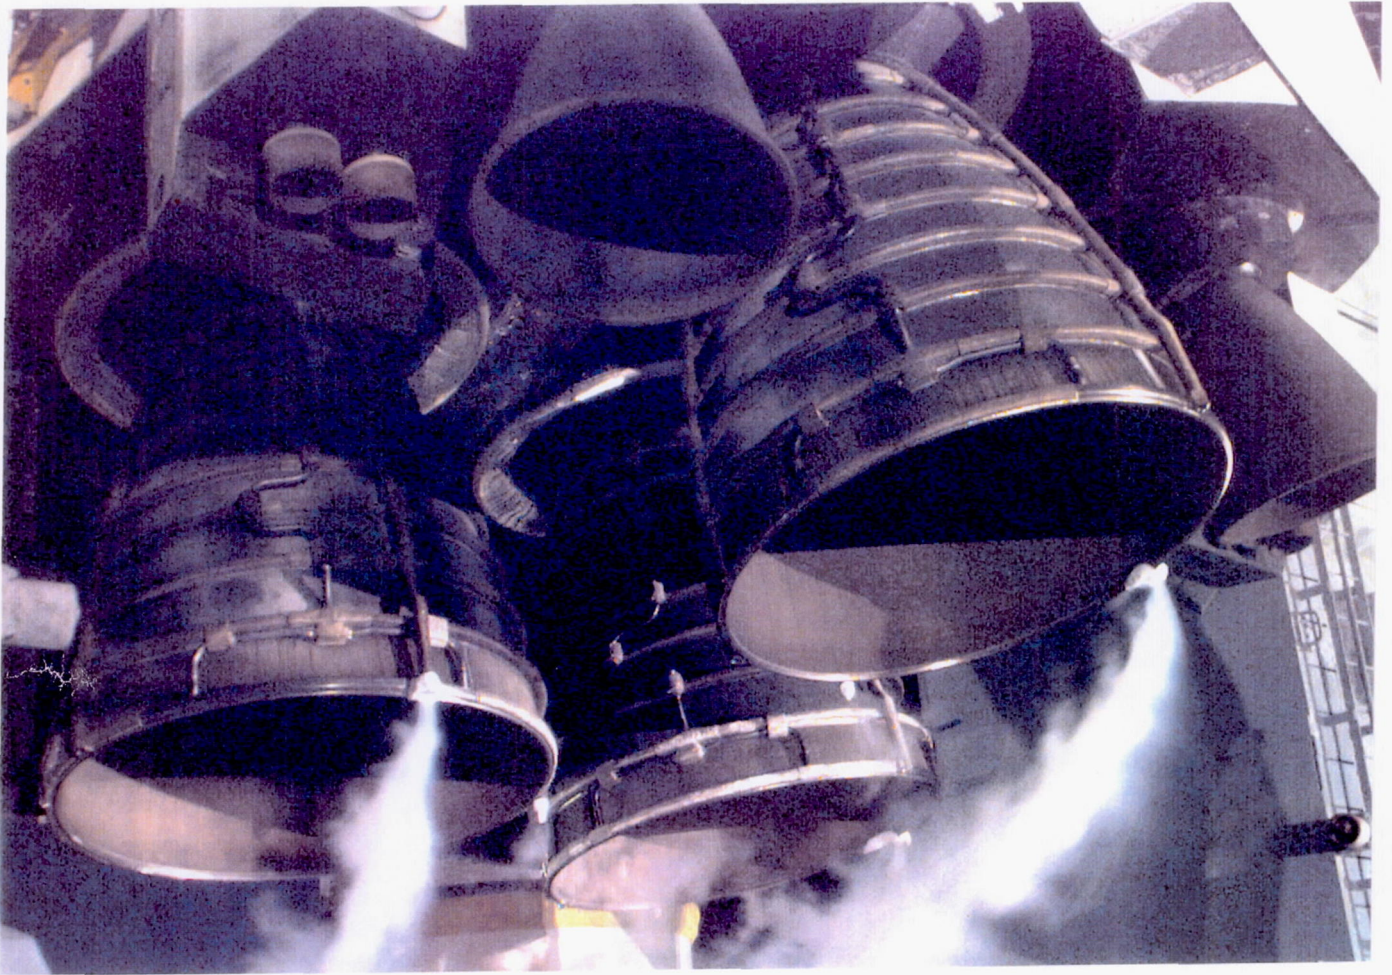
Photo 7: Overall View of SSME's

No Orbiter tile or RCC panel anomalies were observed. The F3L, R1R, R2R, and L4L RCS thruster covers were tinted green indicating small internal vapor leaks. No ice/frost had formed on the SSME heat shield-to-nozzle interfaces. An infrared scan revealed no unusual temperature gradients on the base heat shield or engine mounted heat shields.
